Deer Creek Erosion Control Project

FINAL REPORT

California State University, Chico Research Foundation

August, 2001

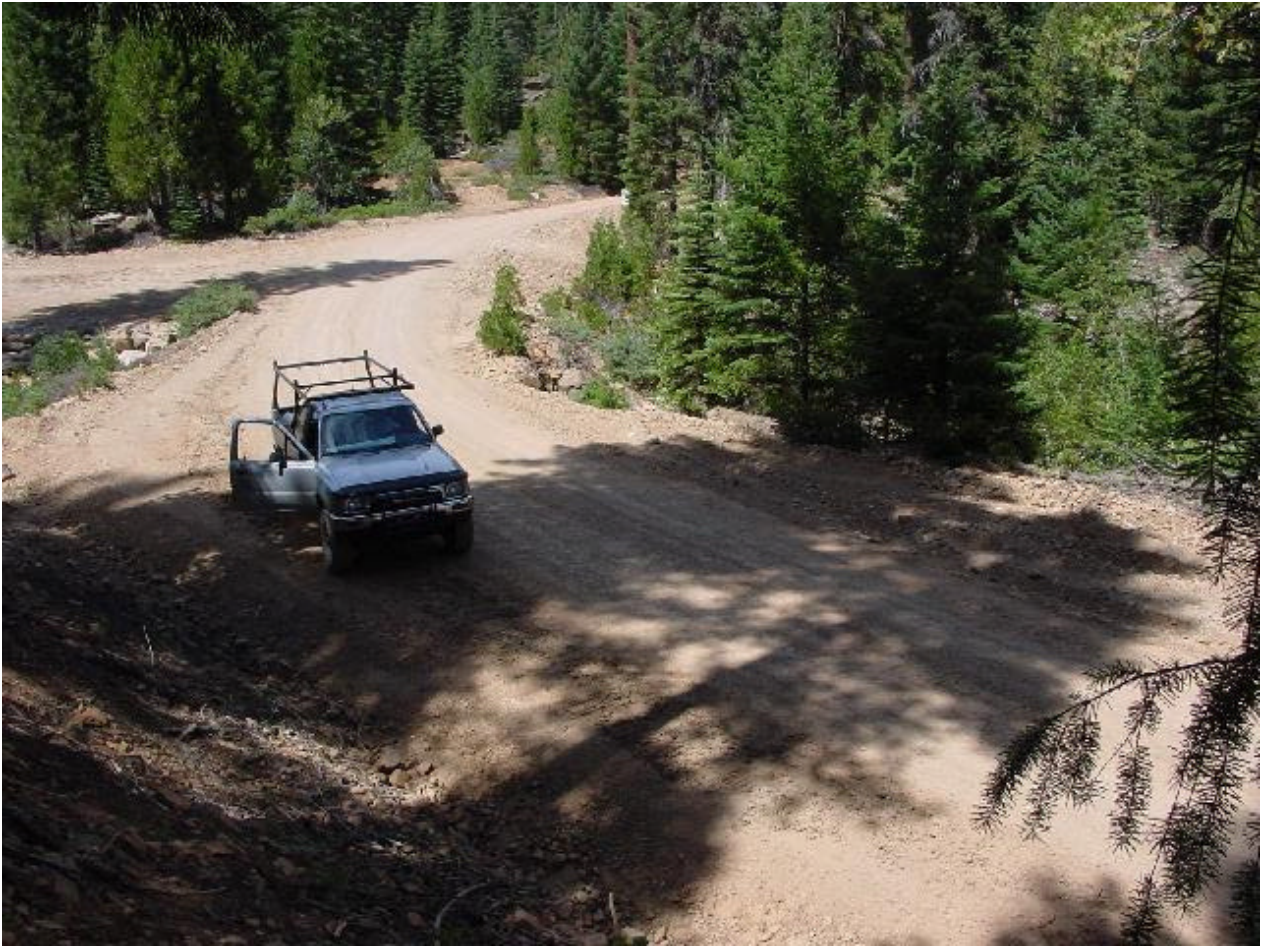
Photo 17.e

Main Road I— Swamp Creek bridge – Broad view of proposed new location

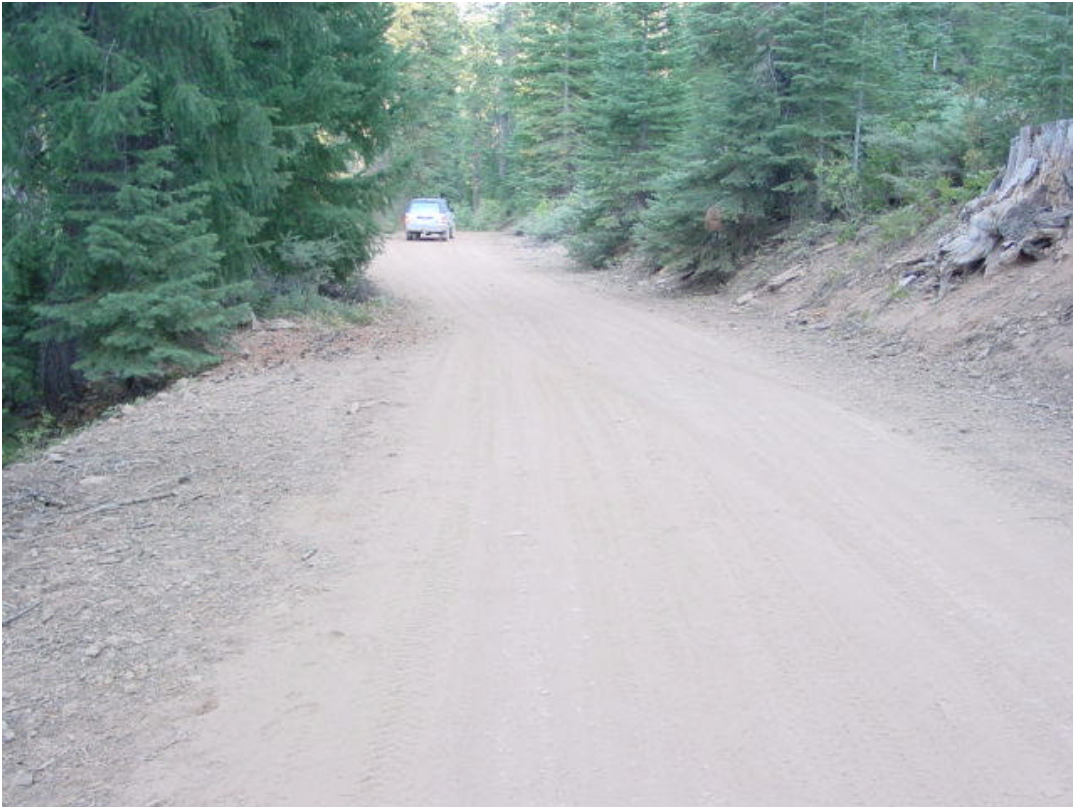
Photo 18.a

Site 18: 1900 Road Surface

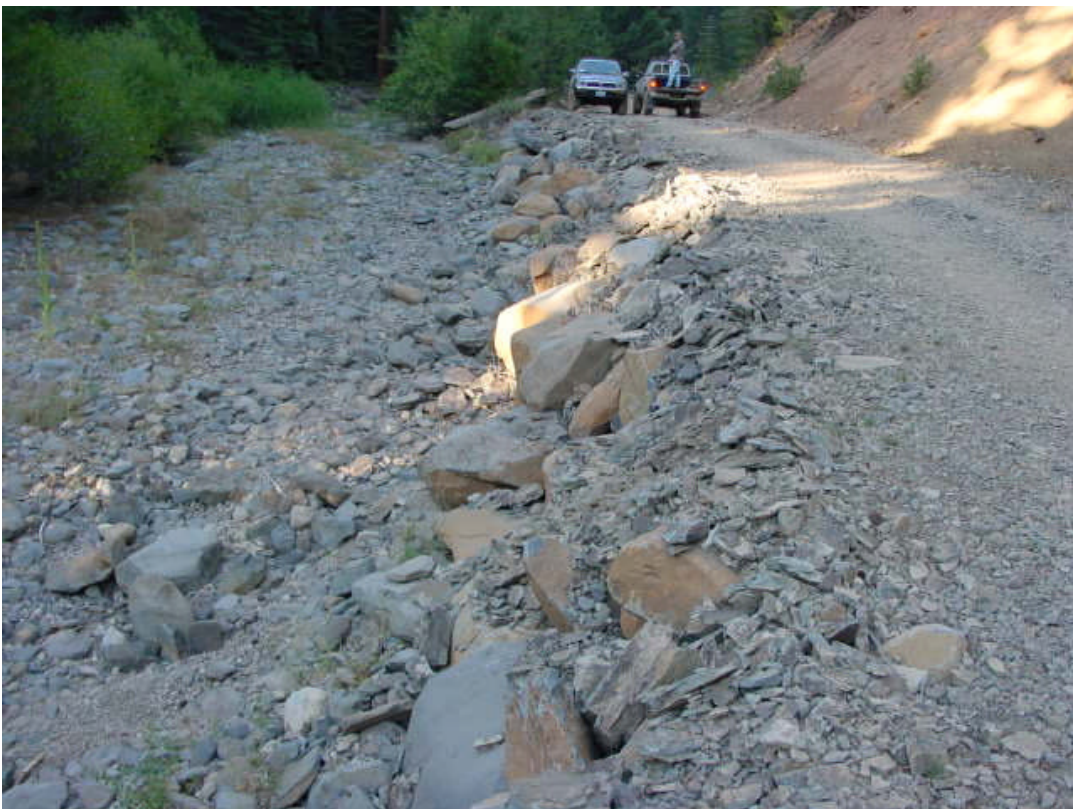
Photo 18.b

Site 18: 1900 road riprap project

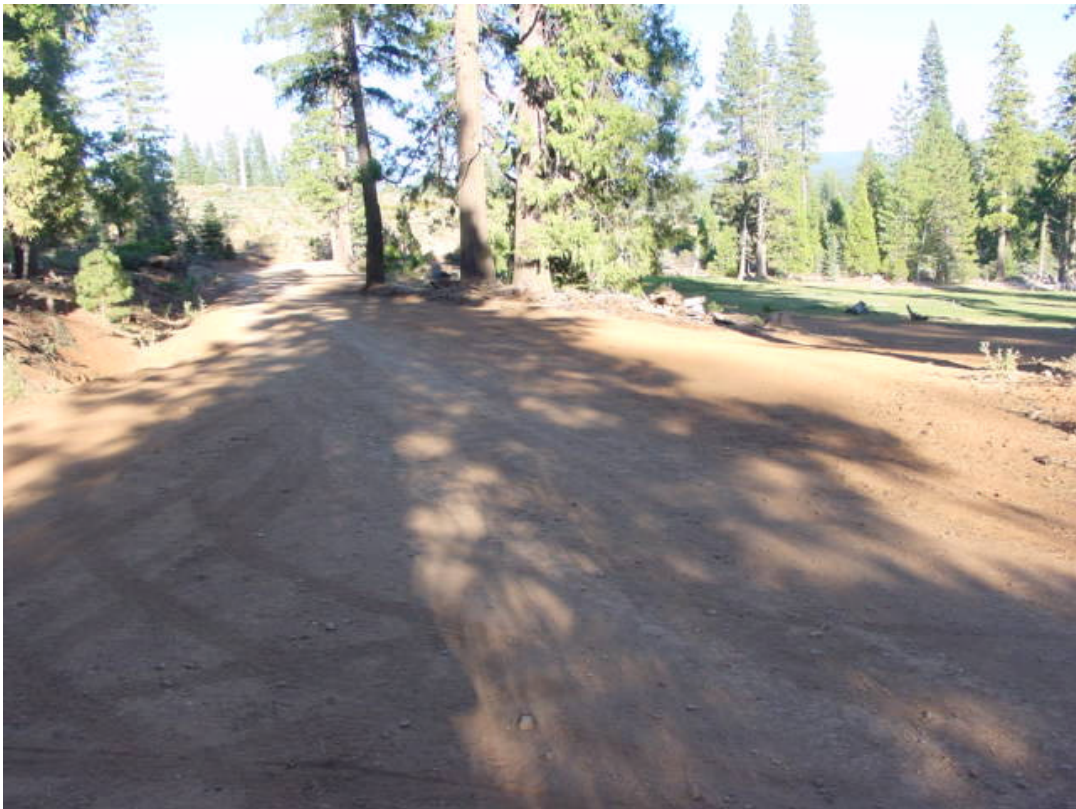
Photo 19.a

Existing surface Main Road I at Round Valley.

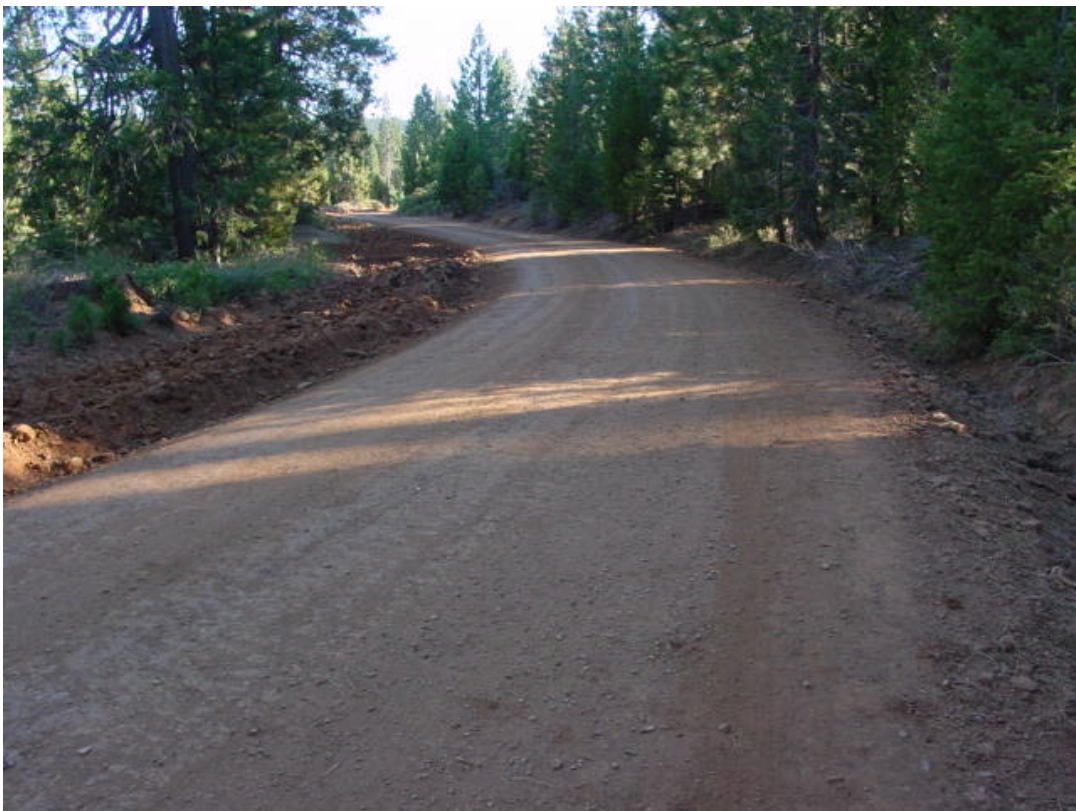
Photo 19.b

Existing surface Main Road I west of Round Valley.

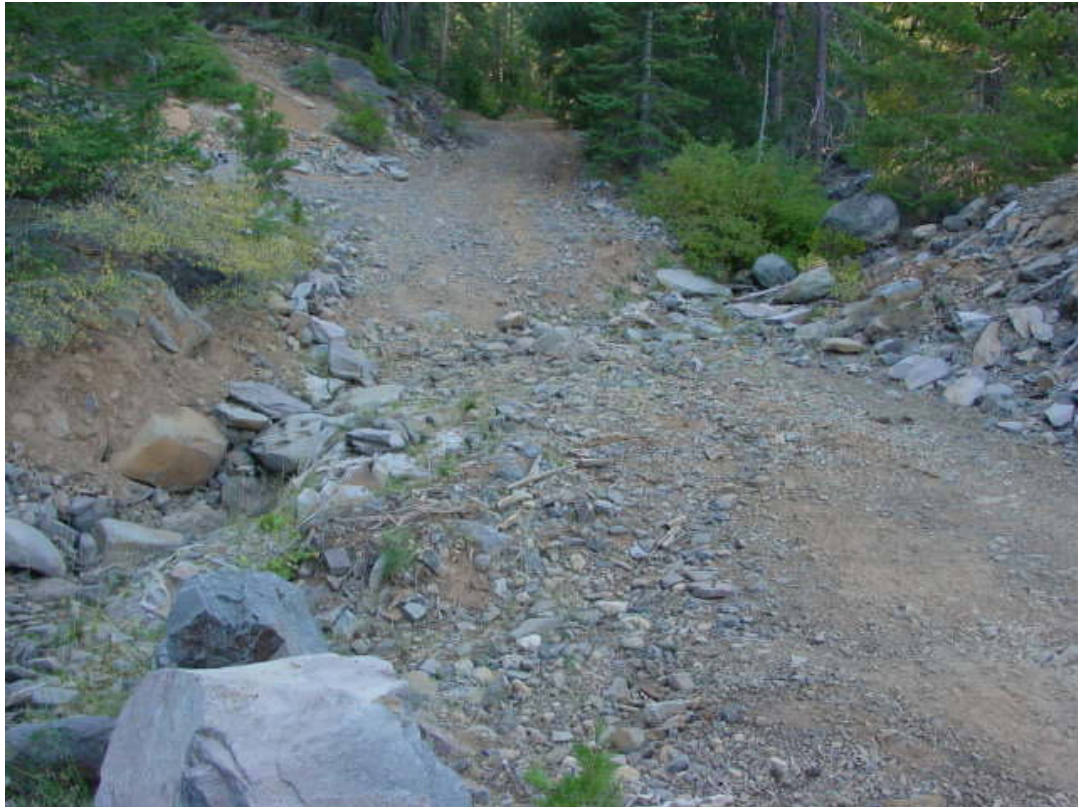
Photo 20.a

2200 Spur—Low water ford on east loop.

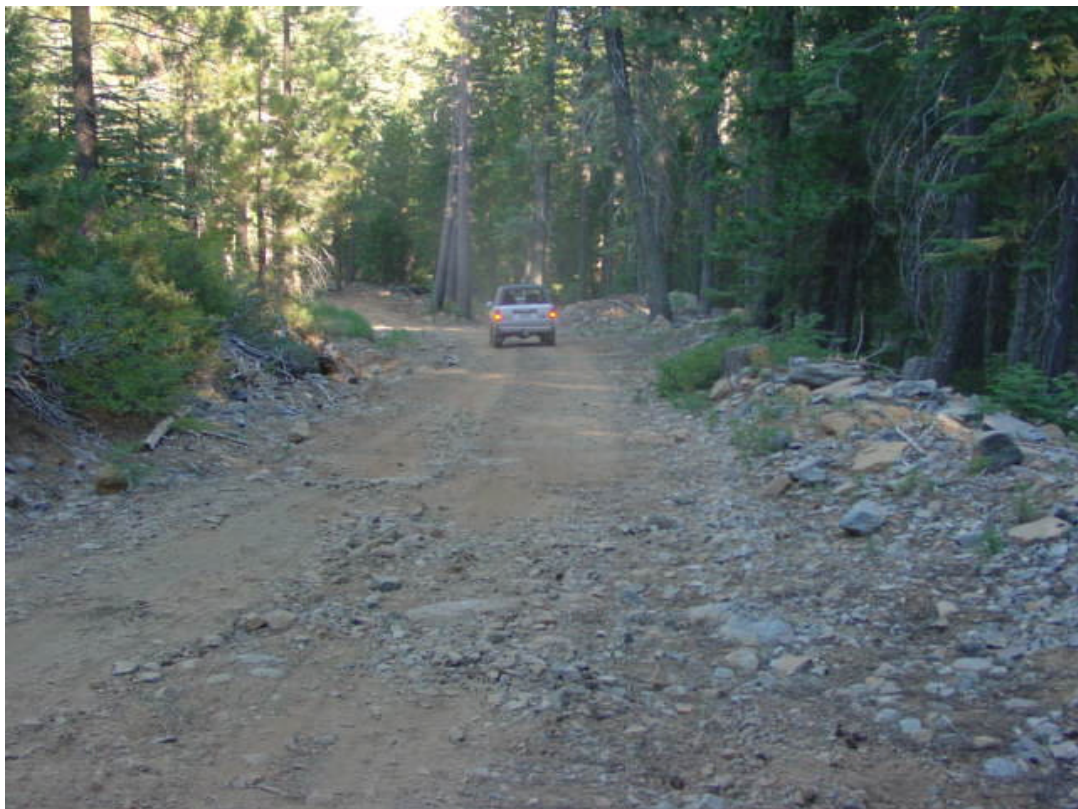
Photo 20.b

2200 Spur—End of 12% grade below low water ford.

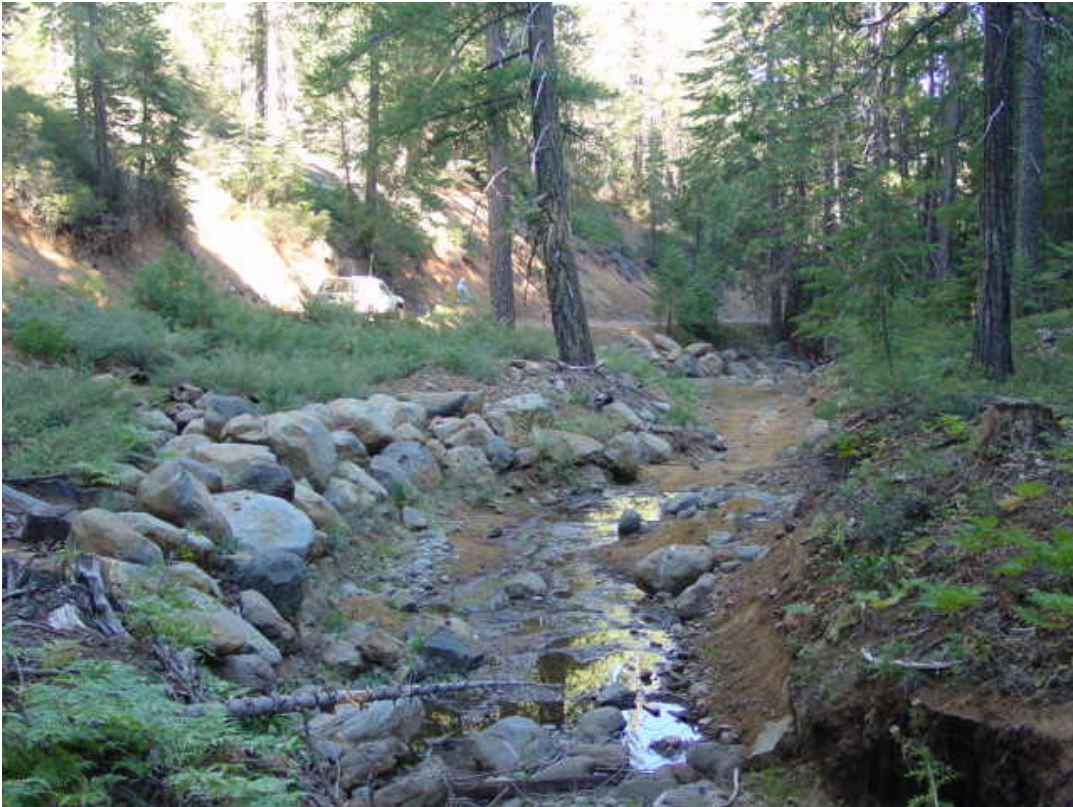
Photo 20.c

2200 Spur—10 year old rip rap between channel and road.

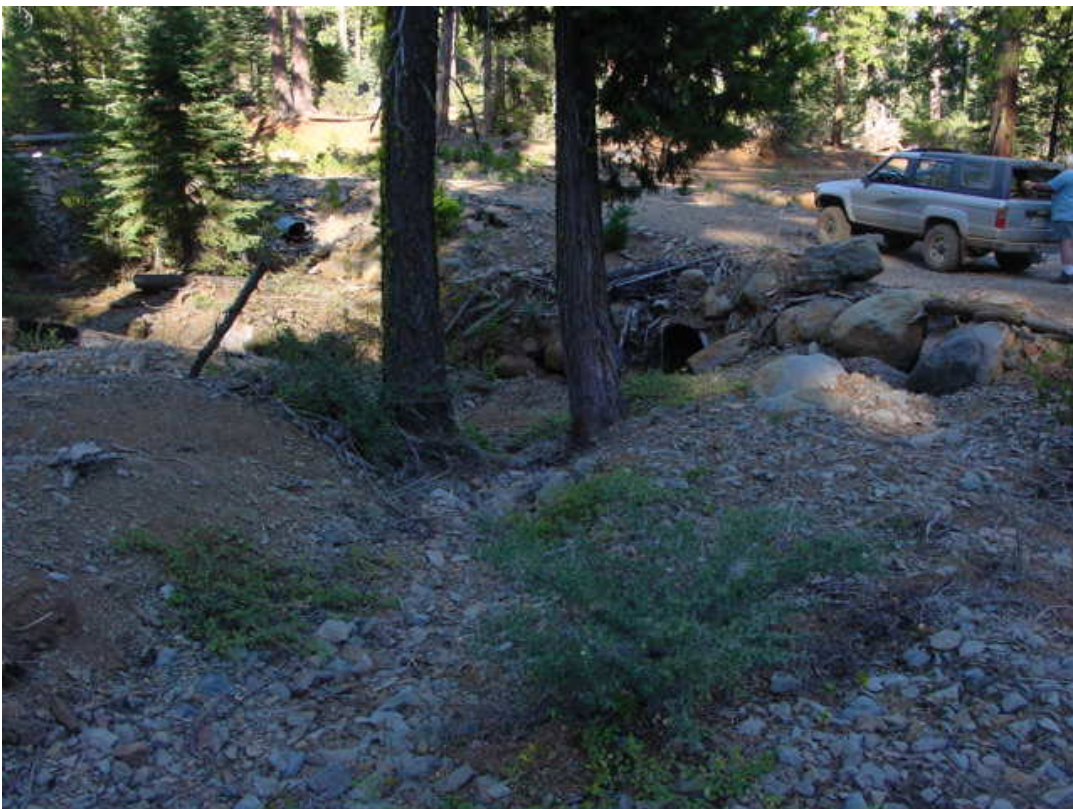
Photo 20.d

2230 Spur—Crossing Round Valley Creek; 2200 Spur in background.

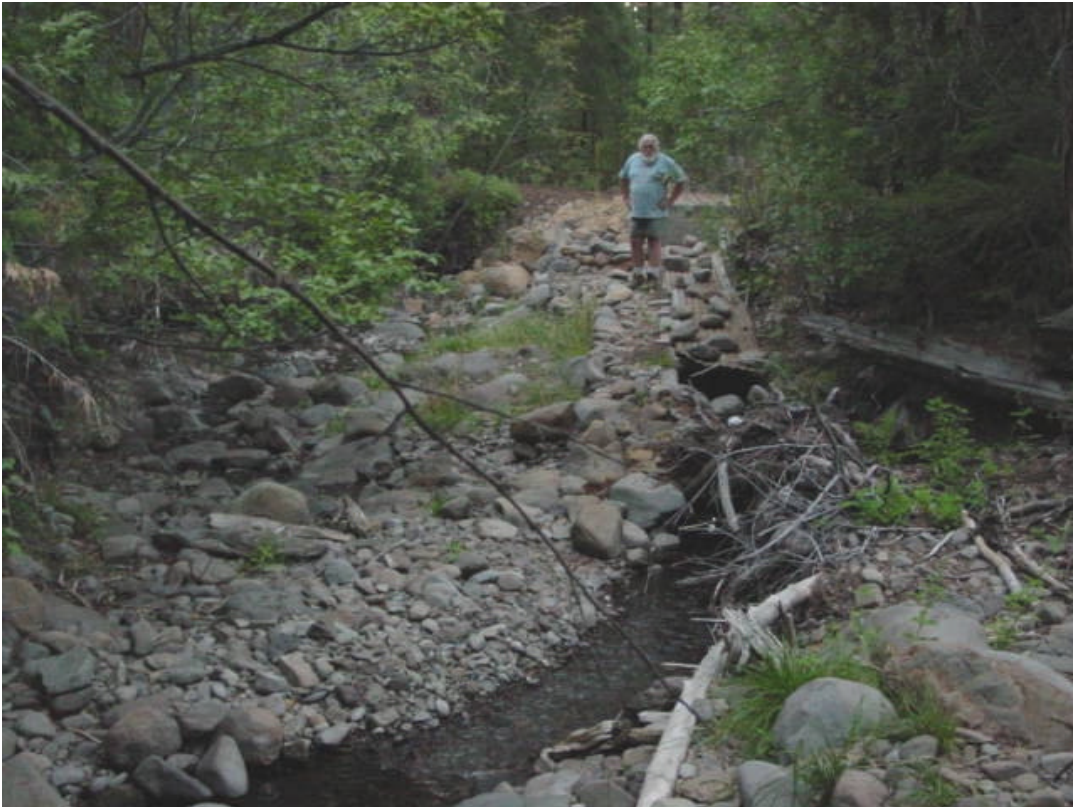
Photo 22.a

Domestic water supply diversion; note artificial dam in foreground.

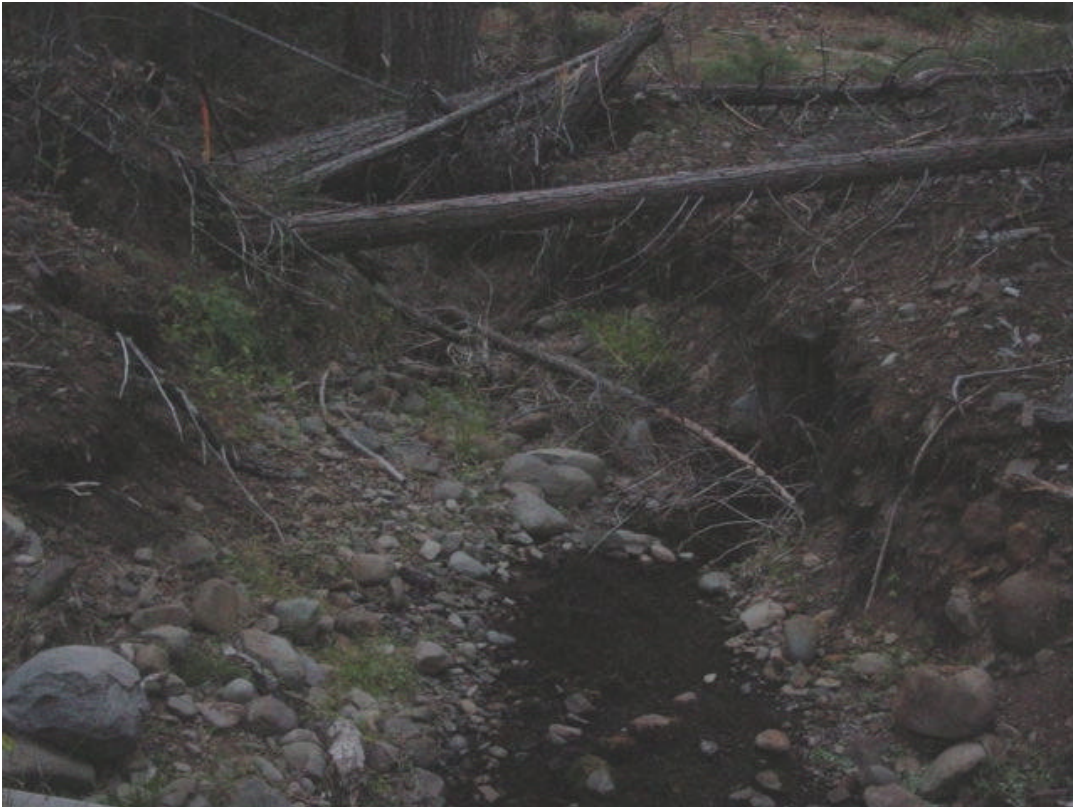
Photo 22.c

Channel erosion and undercut bank trees.

Specifics: Solutions to flood water damage at this site involve both road repair and timber stand improvement, part of which exceeds the management of this grant project. Little can be done within the channel itself, short of placing rip rap along the eroded banks, as demonstrated in Photo 22.d. Reducing, though not excluding, the volume of large woody material in the stream and along its banks might reduce erosion caused by creation of new channels. Flood waters must be excluded from using existing roads or skid trails as secondary channels.
